DEPARTMENT OF TRANSPORTATION

Quality Assurance and Source Inspection

Contract #: 04-0120F4Cty: SF/ALA Rte: 80 PM: 13.2/13.9File #: 99.28**WELDING INSPECTION REPORT****Resident Engineer:**Siegenthaler, Peter**Address:** 333 Burma Road**City:** Oakland, CA 94607**Report No:** WIR-017404**Date Inspected:** 03-Oct-2010**Project Name:** SAS Superstructure**OSM Arrival Time:** 700**Prime Contractor:** American Bridge/Fluor Enterprises, a JV**OSM Departure Time:** 1900**Contractor:** Zhenhua Port Machinery Company, Ltd (ZPMC) Chanxing Island**Location:** Shanghai, China**CWI Name:** Mr. Xu Tao**CWI Present:** Yes No**Inspected CWI report:** Yes No N/A**Rod Oven in Use:** Yes No N/A**Electrode to specification:** Yes No N/A**Weld Procedures Followed:** Yes No N/A**Qualified Welders:** Yes No N/A**Verified Joint Fit-up:** Yes No N/A**Approved Drawings:** Yes No N/A**Approved WPS:** Yes No N/A**Delayed / Cancelled:** Yes No N/A**Bridge No:** 34-0006**Component:** OBG Segment & Bike Path**Summary of Items Observed:**

WELDING INSPECTION REPORT

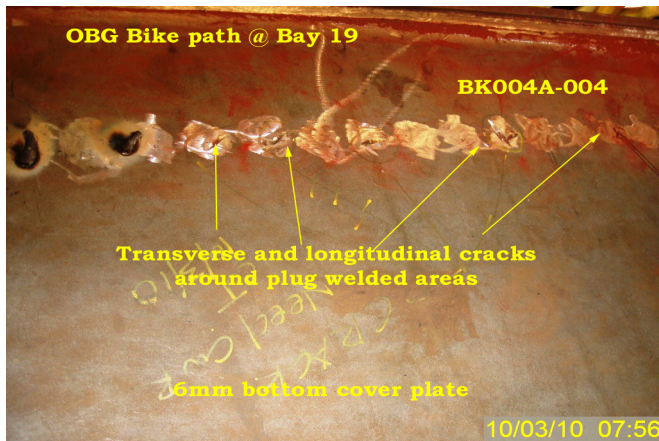
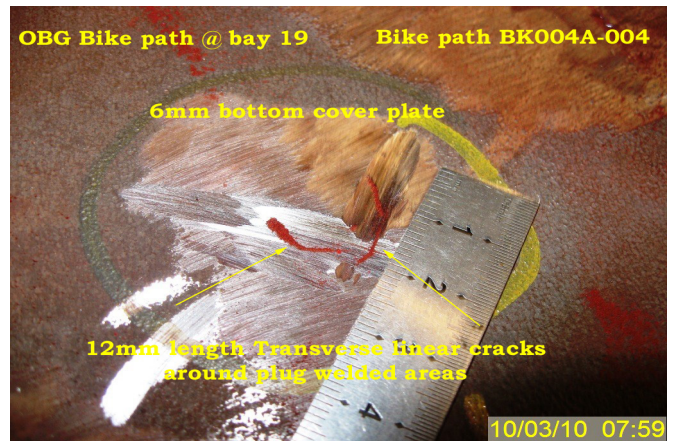
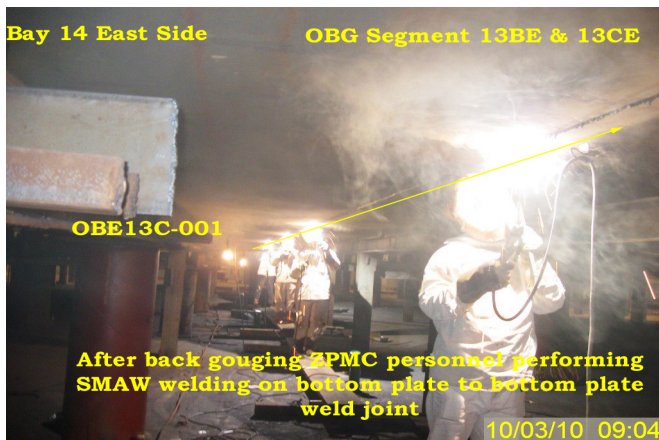
Description of Incident: During random in-process visual inspection of welds located on OBG Bike path at bay 19, this Quality Assurance Inspector (QA) observed that ZPMC personnel performing repair welding on bottom cover plate plug weld repair area with cracks. QA is visually found more than 10 spots transverse and longitudinal cracks around plug welded areas. ZPMC welding personnel performed welding over cracks. The cracks are not removed completely. This QA requested to ZPMC QC, to prepare critical welding report and remove the cracks and cross check with MT and after that perform welding on repaired areas. The bike path number is identified as BK004A-004. The weld is non Seismic Performance Critical Members (non SPCM). The thickness of the bottom cover plate is 6mm. This bike path is located at bay #19. The indications are clearly marked by QA on/near the weld. See the attached picture.
